Essex County Council Flood Investigation Report

Helions Bumpstead

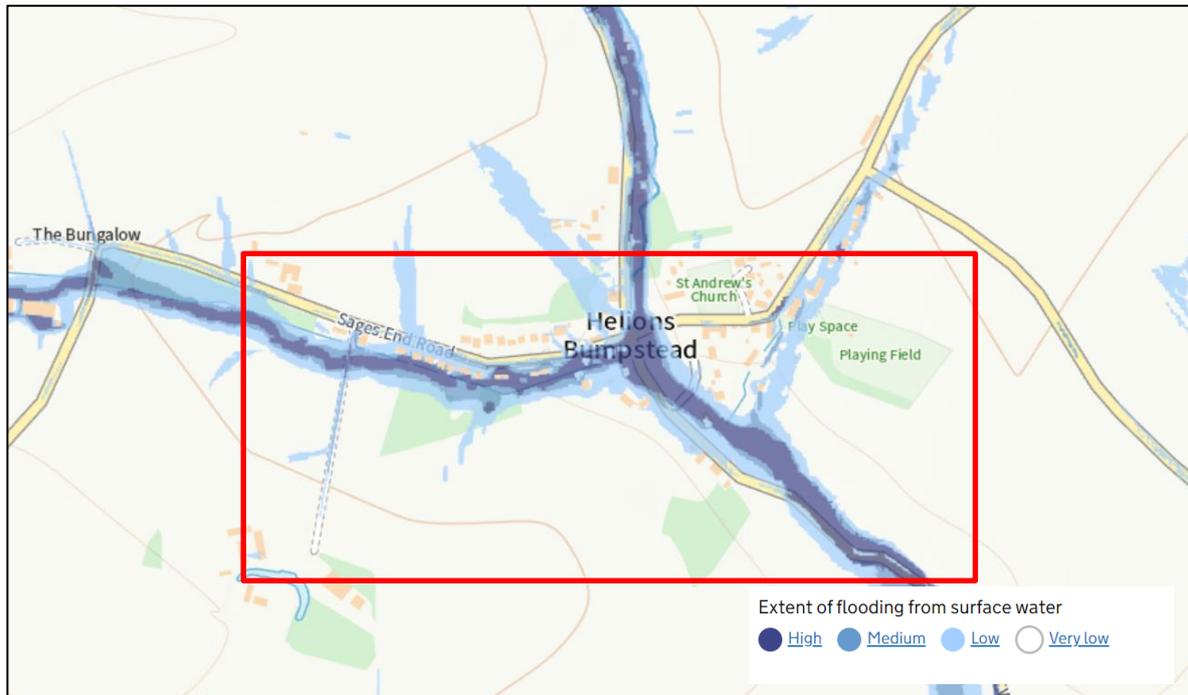
Figure 1 – Flood Investigation Area shown in red and Risk of Flooding Surface Water (Base Map: Ordnance Survey, 2021; Flood Map: Environment Agency, 2021).

Properties have flooded internally within the village of Helions Bumpstead. Figure 1 shows most of the investigation area has a high risk of flooding from surface water; high risk means that each year this area has a chance of flooding of greater than 3.3% (fig.1).

Large areas of the village are shown to be at high surface water flood risk with mapped flow paths following known watercourses within the village. Flow paths north to south and west to east converge in the center of the village near to the crossroads. Further overland flow is shown to flow across field to the east of the village, there is a watercourse adjacent to this flow path however mapped flood flows do not follow this. The surface water flood risk can be viewed [here](#).

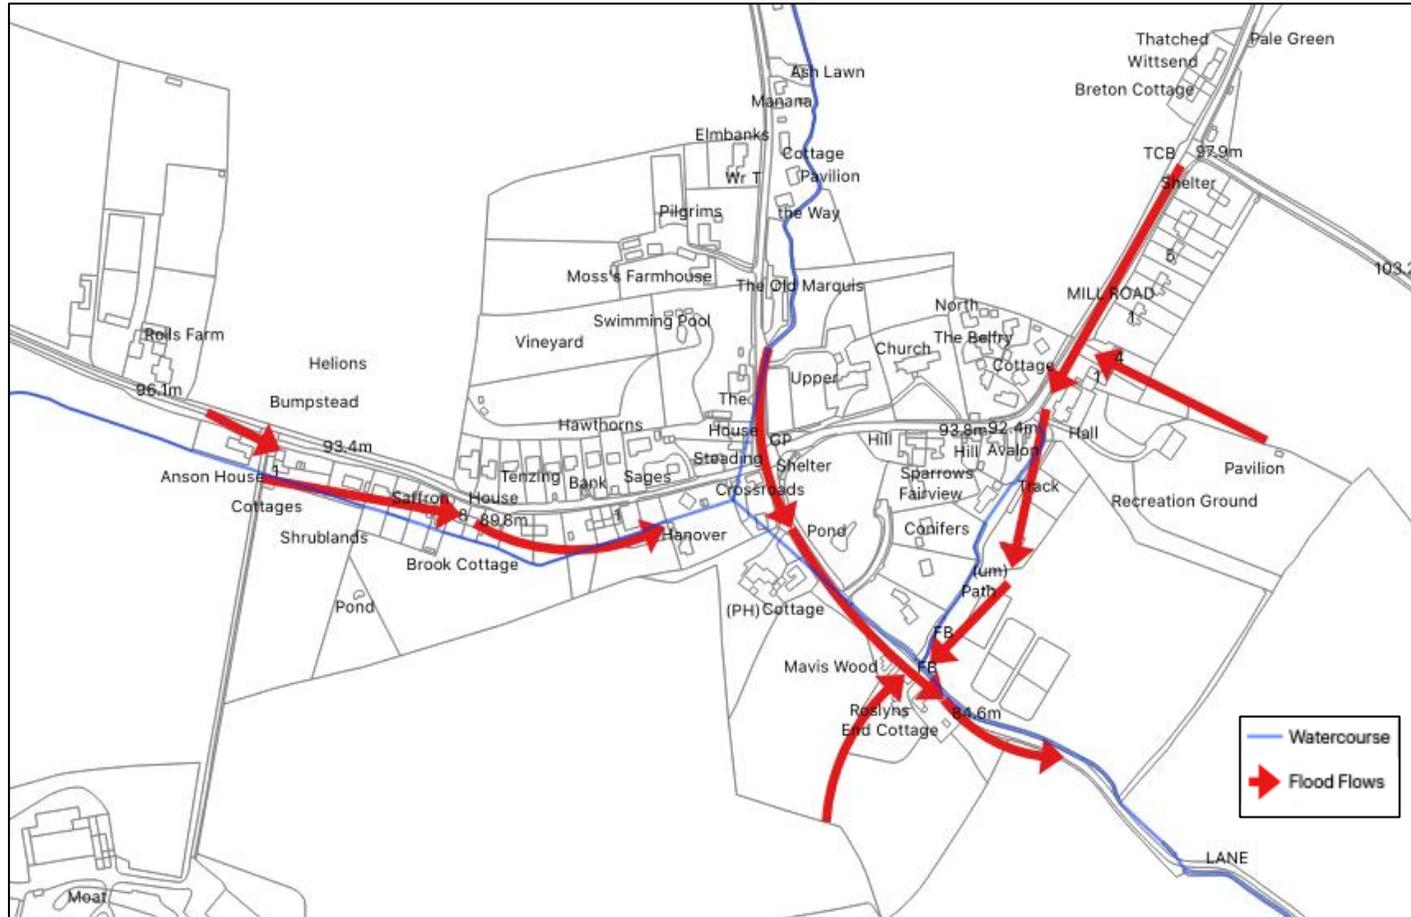
Figure 2 – Indicative Drainage Layout (Ordnance Survey, 2021).

Figure 2 shows the indicative layout of the primary drainage infrastructure in the area, the information was obtained from Environment Agency (EA) Detailed River Network (DRN) Mapping, EH, Anglian Water and site observations.

The flood flows were reported to flow the National Flood mapping (fig.1) and route of the known watercourses (fig.2) with out of bank flows reported where there are restrictions within the system, including blockages and reduced culvert sizes.

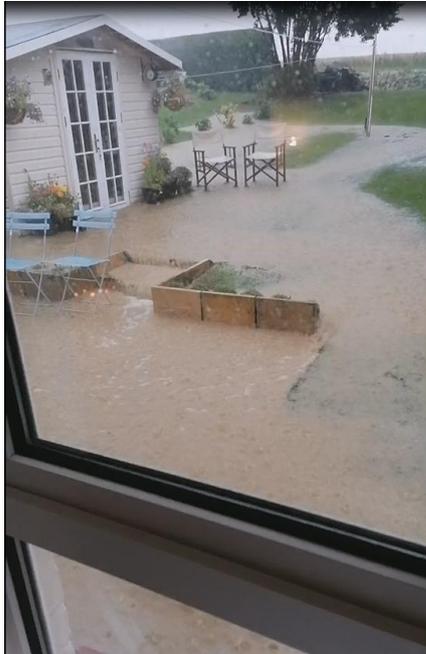
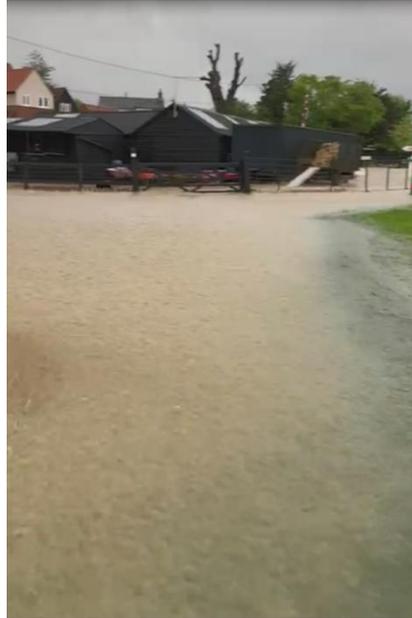
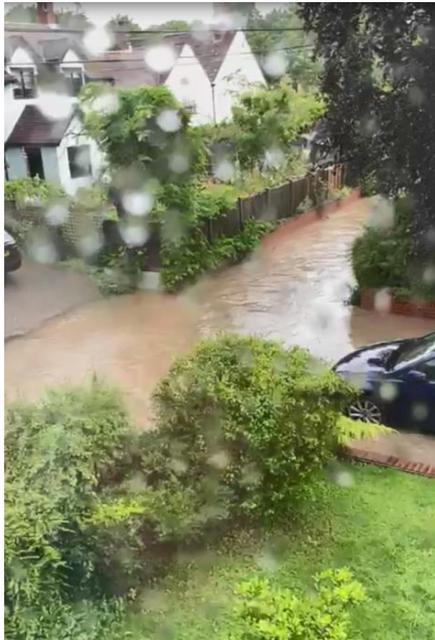
Appendix A – Photos from 25th July 2021 (Provided by residents).
